## Test Report

Order : Test of the water-tightness of a concreted in coated liner pipe ZVR DN 100 with annulus gasket HRD 100

Kiwa MPA Bautest GmbH received an order from Hauff-Technik GmbH & Co. KG to perform a water leak test on a concreted-in coated liner pipe ZVR DN 100 with annulus gasket HRD 100.

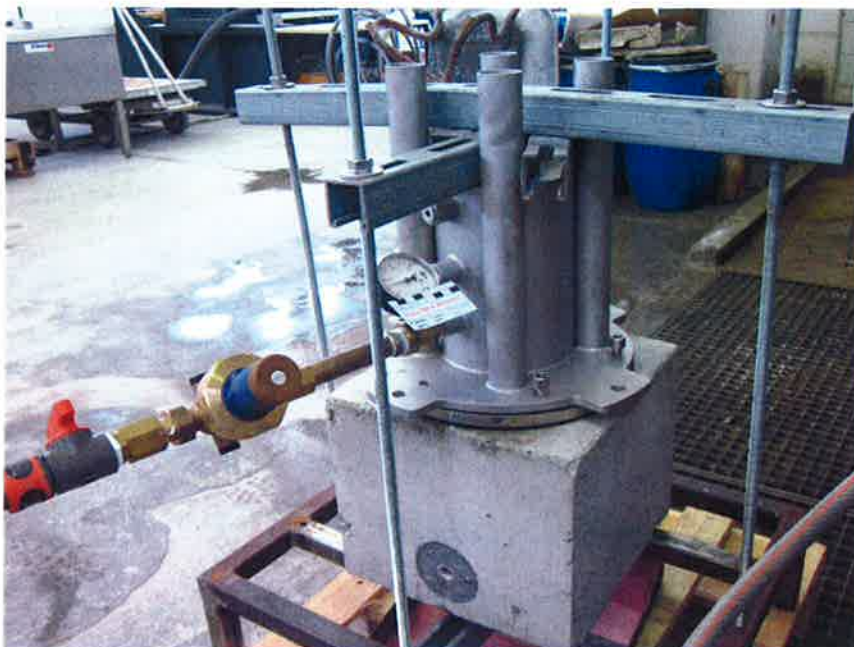
To this end, Hauff-Technik GmbH & Co. KG delivered a ready-assembled test setup with a concreted-in coated liner pipe ZVR DN 100 with annulus seal HRD 100 to our laboratory in Augsburg (see Figure 1). The test bell was secured by the client using square steel sections.

Figure 1: Test setup

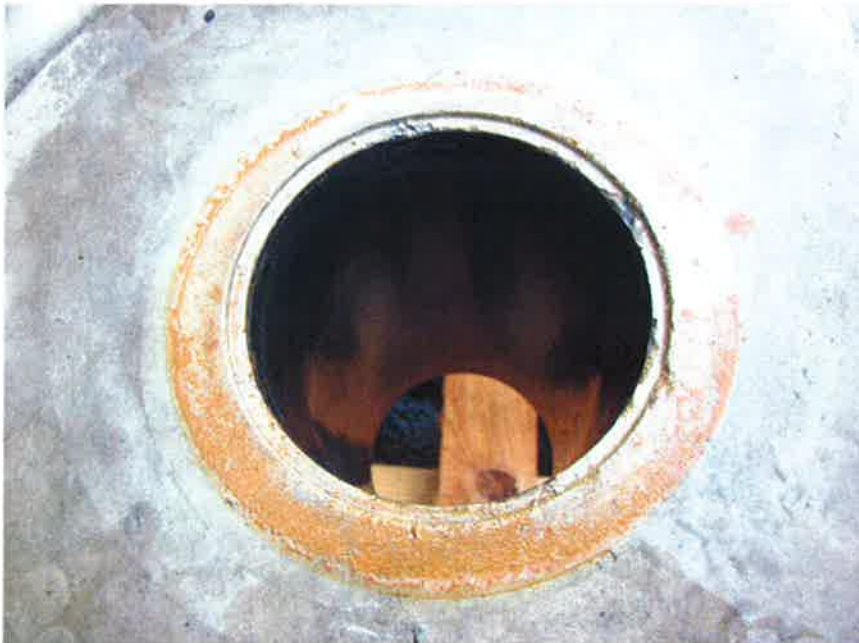
Figure 5: View - top of the test setup; concreted-in coated liner pipe ZVR DN 100

The test body delivered by Hauff-Technik GmbH & Co. KG is a test setup assembled by the manufacturer according to 2.1 with pre-installed pressure gauge and pressure reducer (see Figure 2 to Figure 5). Kiwa MPA Bautest GmbH did not calibrate the pressure gauge delivered in the test setup.
